**DEPARTMENT OF TRANSPORTATION****DIVISION OF ENGINEERING SERVICES**

Contract #: 04-0120F4Cty: SF/ALA Rte: 80 PM: 13.2/13.9File #: 69.15**SOURCE INSPECTION REPORT****Resident Engineer:** Pursell, Gary**Address:** 333 Burma Road**City:** Oakland, CA 94607**Report No:** SIR-000539**Date Inspected:** 14-Apr-2009**Project Name:** SAS Superstructure**OSM Arrival Time:** 0**Prime Contractor:** American Bridge/Fluor Enterprises, a JV**OSM Departure Time:** 12**Contractor:** Zhenhua Port Machinery Company, Ltd (ZPMC), Changxing Island **Location:** Changxing Dao, Shanghai

## SOURCE INSPECTION REPORT

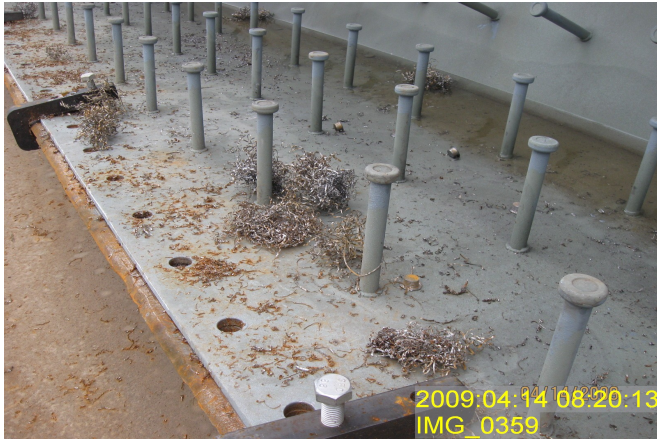
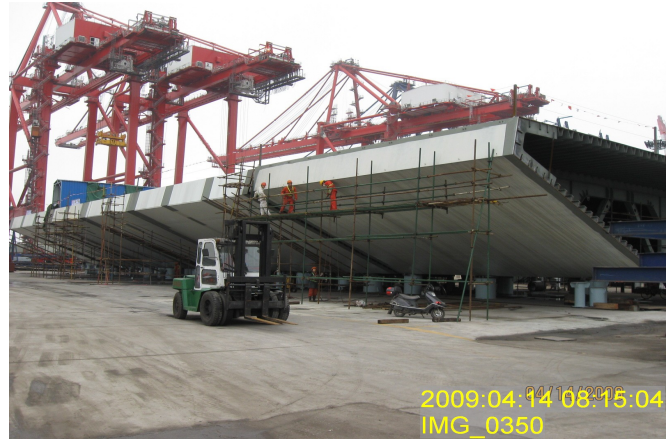
Caltrans QA Coatings Inspector Jordan visited the OBG assembly area to see the progress and assess the coatings damage to be repaired. The counterweight sections previously abrasive blasted and primed had metal shavings, puddle water and rust stains on them from yesterdays rain. ZPMC's Bevin Dong was informed of the issue. The specification requires the rust stains to be blast removed and recoated. It was suggested to Mr. Dong that the shavings be cleaned up and the stains cleaned off before the rust reaches the point it cannot be removed by washing or rubbing. If the stains do cannot be removed the pieces will have to be re-blasted. He said he would have the pieces cleaned and talk to the fabrication foreman about cleaning up after the drilling from now on.
